# Story of a Landscape: Solving Water Infiltration Problem in California Yard

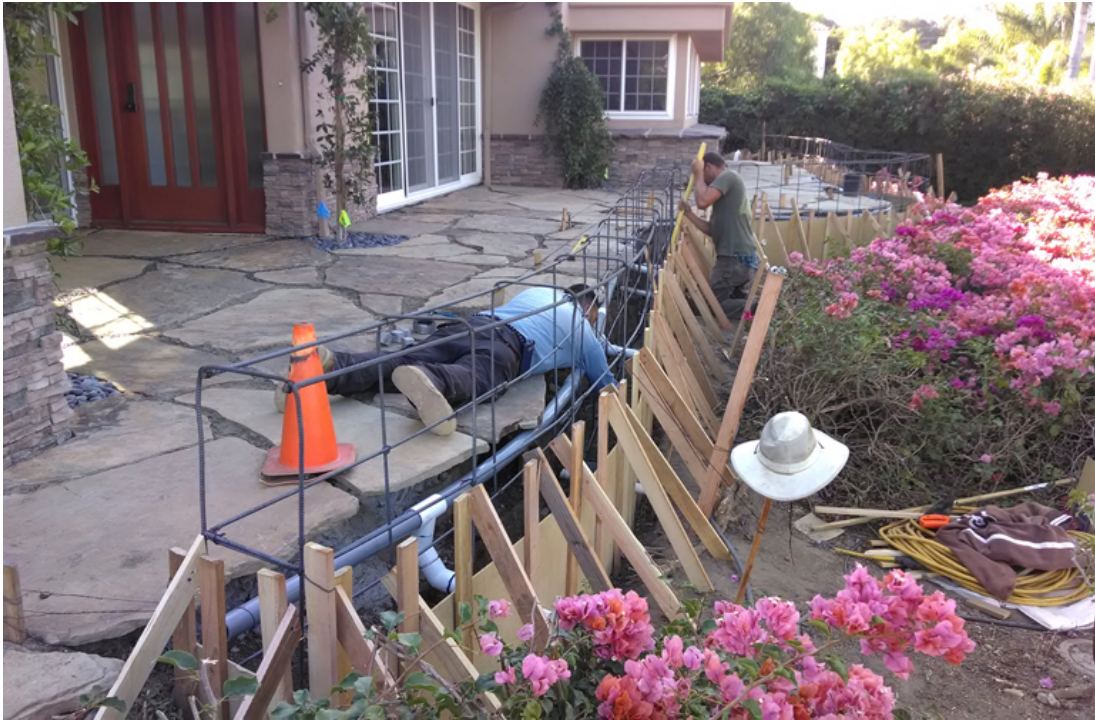
The ferrocement wall was challenging because of the existing poorly constructed block wall and the need for drainage.

Wilson says the ferrocement wall was quite complicated because of the existing poorly constructed block wall and the need for drainage.

"We had to get drainage water away from the house, but first had to figure out how to drain the water through an impervious ferrocement wall, as well as take water from the subsurface behind the wall," he says. "It led to some pretty unique plumbing inside the rebar structure of the wall. There were definitely some technical challenges involved."

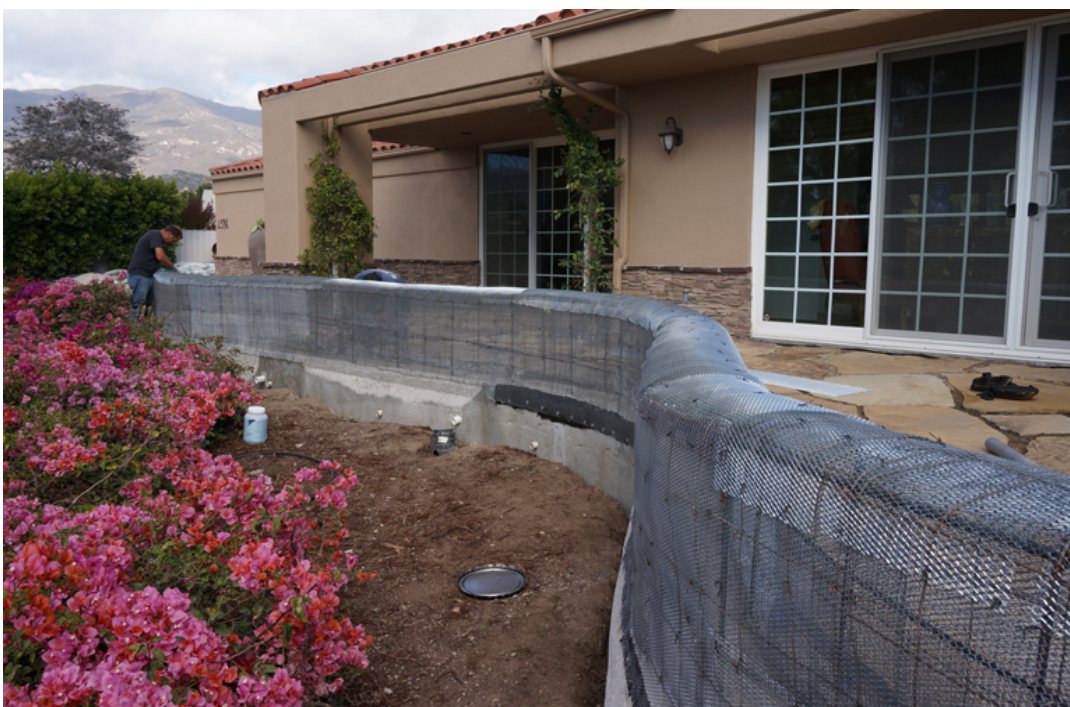
A 100-foot curving ferrocement wall to retain the slope near

the home's foundation. PHOTO: Wilson Environmental Contracting, Inc.

The company also installed a 100-foot curving ferrocement wall outside an existing dry-laid block wall to retain the slope near the foundation, retrofitted sprinklers to drip irrigation and installed an on-site weather station that communicated with a clock to further reduce irrigation.

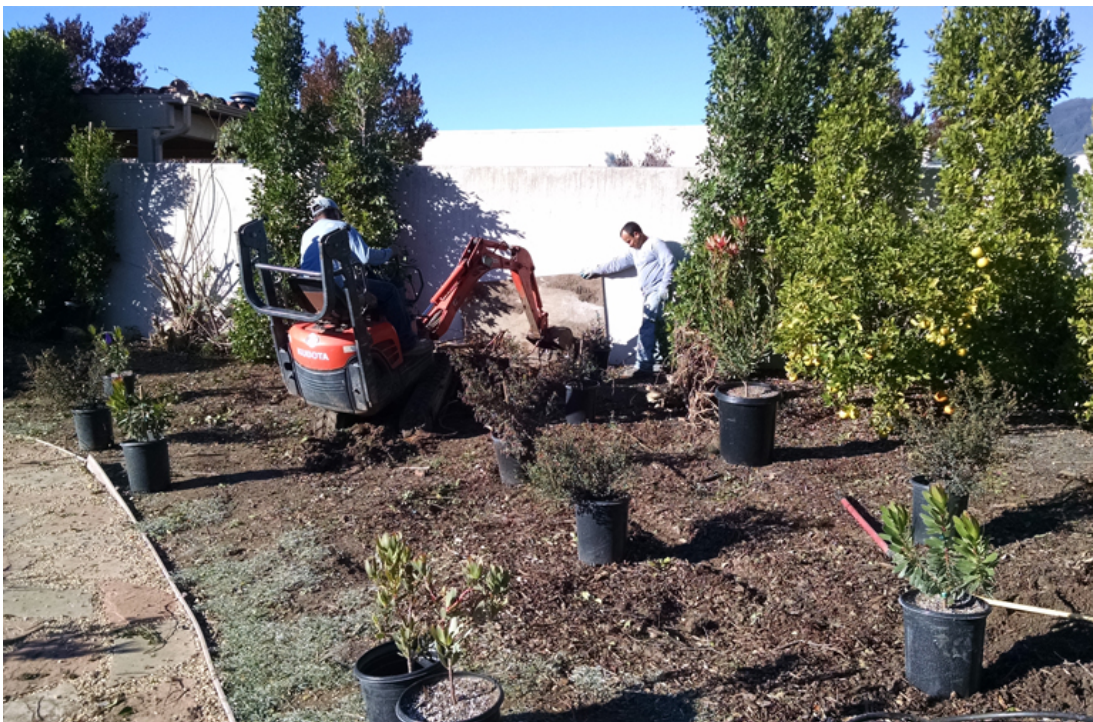
Along with an updated plant selection, the contractor amended and mulched the soil. PHOTO: Wilson Environmental Contracting, Inc.

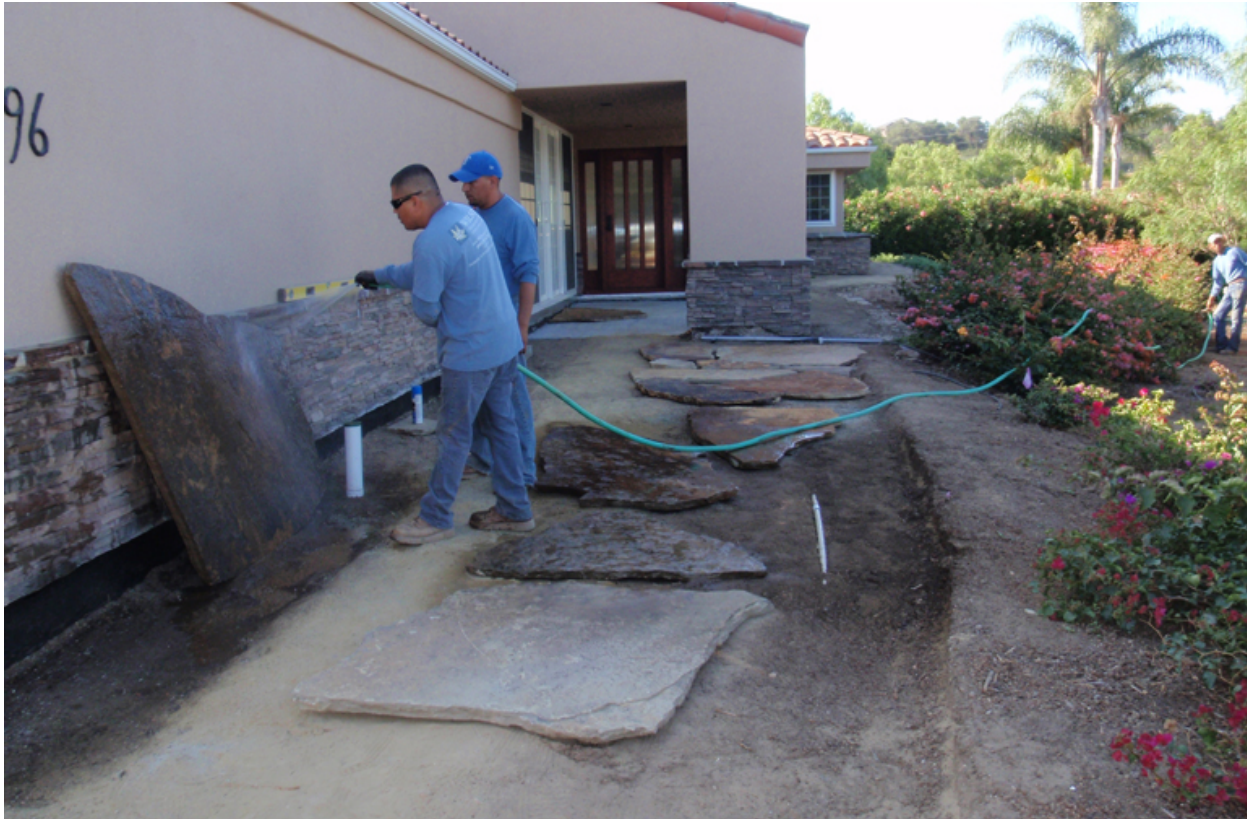
The company balanced this project with existing work as the client's interests developed. PHOTO: Wilson Environmental Contracting, Inc.

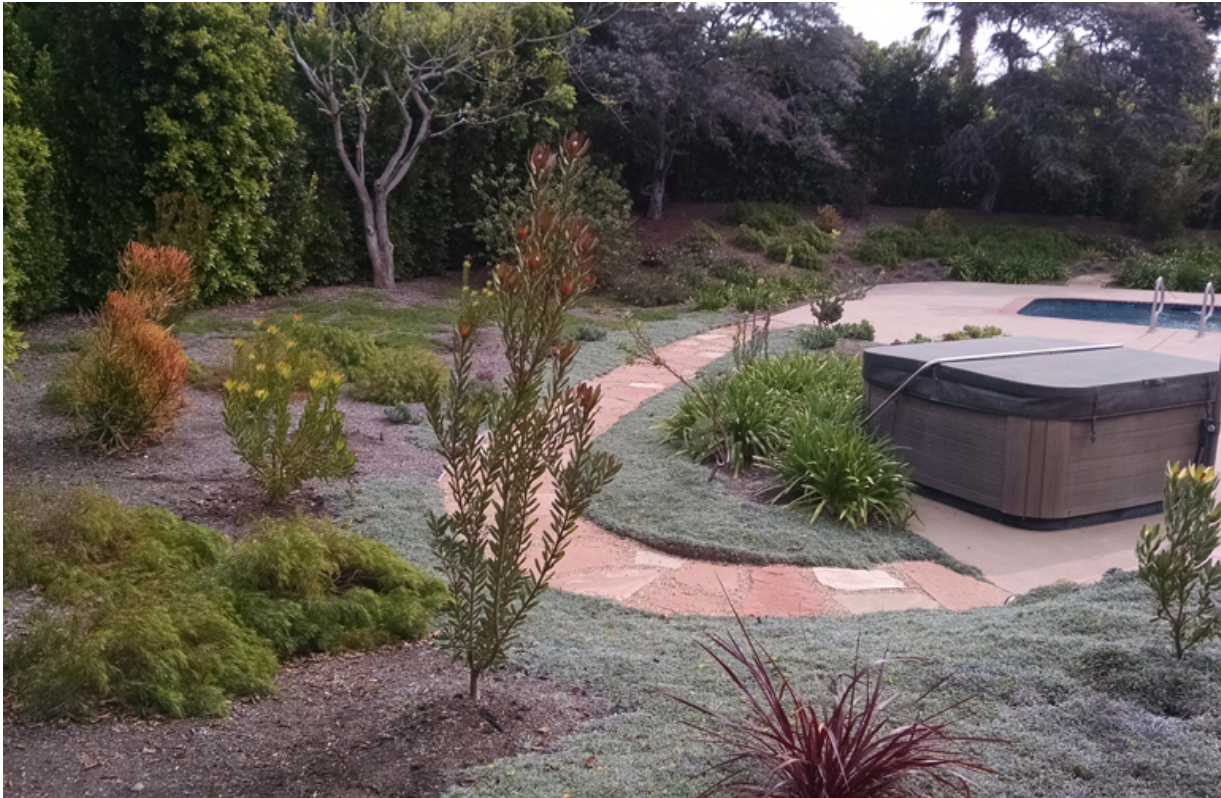
The sprinkler system was completely updated and changed to inline and point-source drip irrigation. PHOTO: Wilson Environmental Contracting, Inc.

“Again, we removed a bunch of plants that were high-water use – mainly roses and jasmine and agapanthus – and replaced them with drought-tolerant ones,” he says. “We also completely overhauled and retrofitted the sprinkler system and changed everything over to inline and point-source drip irrigation, as well as amended and mulched the soil.”

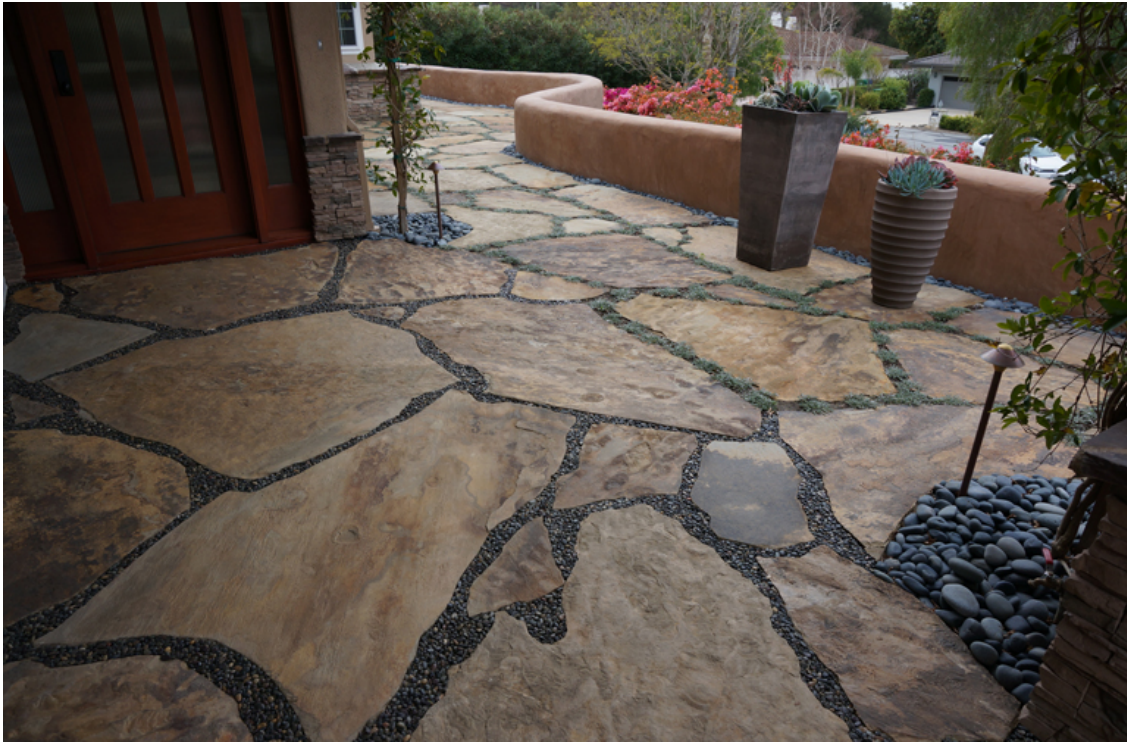
Increased permeability with a flagstone walkway. PHOTO: Wilson Environmental Contracting, Inc.

"We daylighted subsurface drains downslope and created a dry creek bed flowing down along the root zone of a mature pepper tree, and then we removed the concrete sidewalks," Wilson says. "We then increased permeability by replacing the walkway and area around the front of the house with dry laid flagstones with large joints to allow stormwater infiltration."

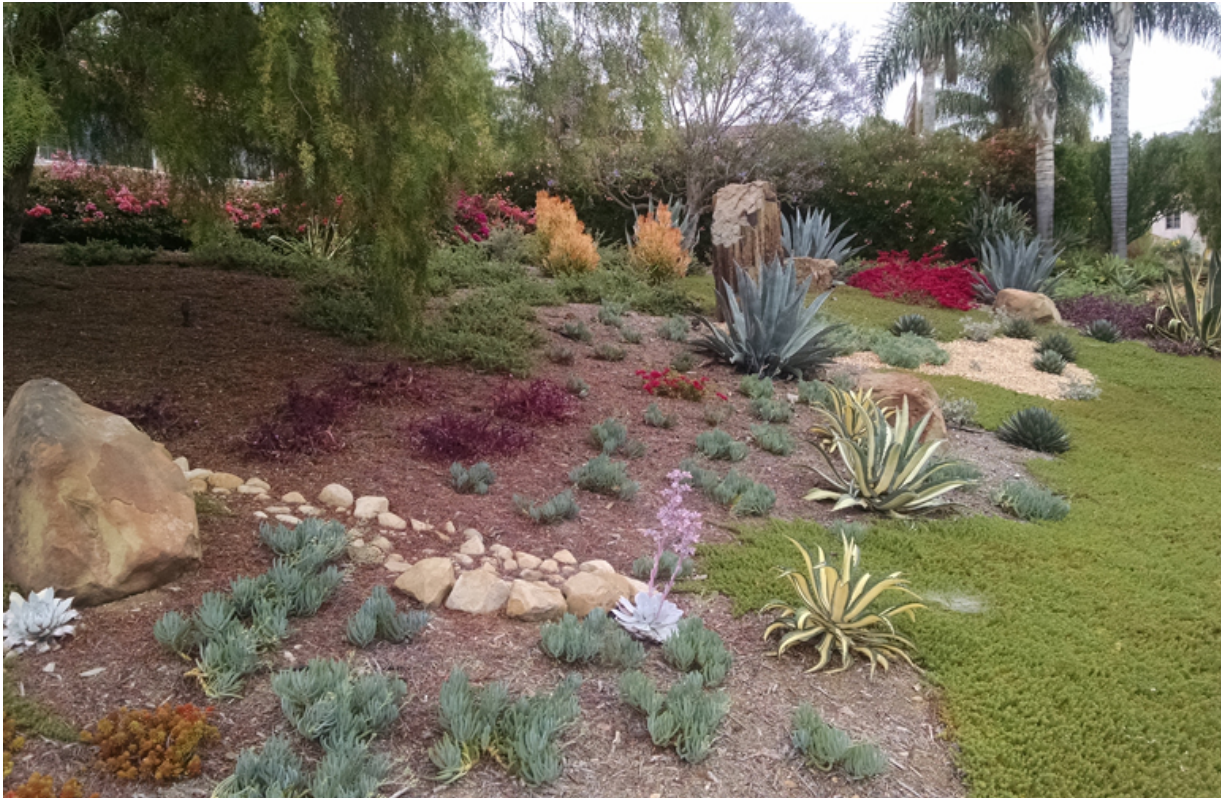
The lawn was replaced with succulents and plants appropriate for the region. PHOTO: Wilson Environmental Contracting, Inc.

To reduce the need for irrigation, Wilson also introduced a new plant palette to the property, replacing lawn with succulents and California- and Mediterranean-originated plants appropriate for the region.

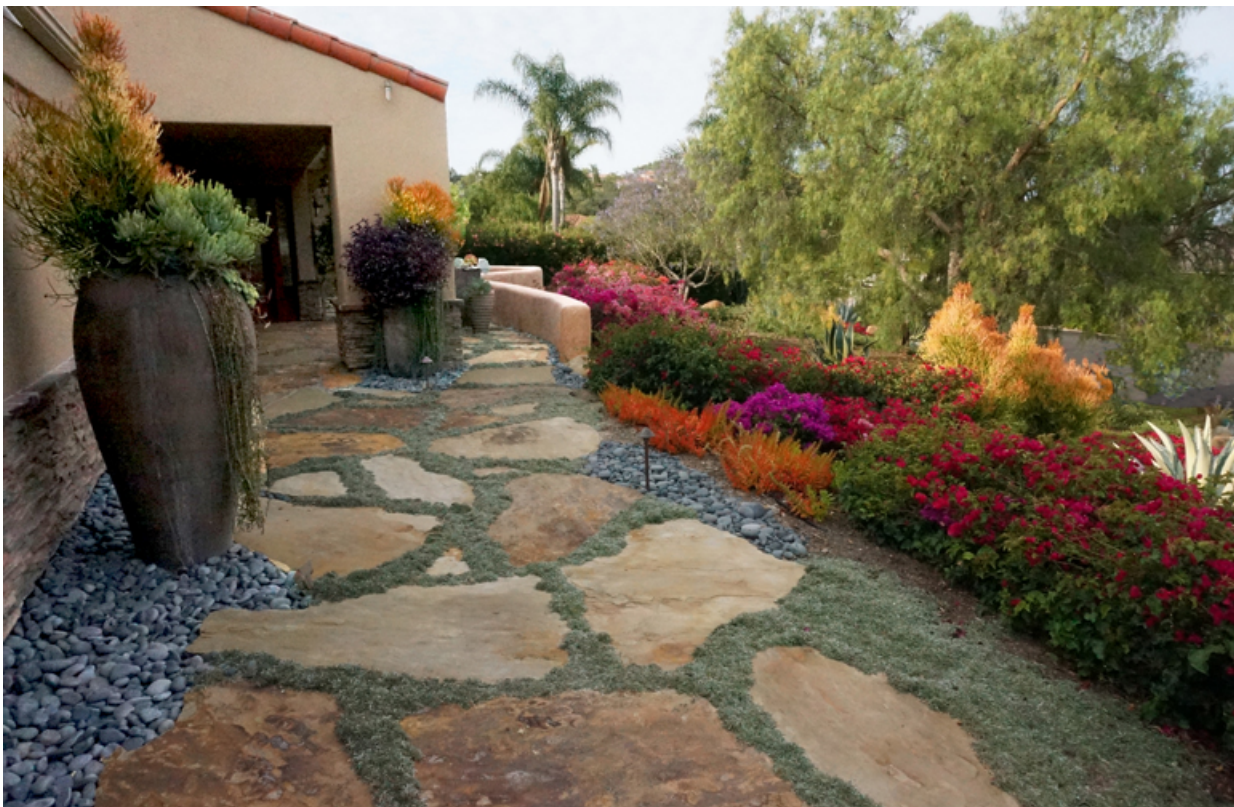
Replacement walkway uses flagstones with large joints to allow for stormwater infiltration. PHOTO: Wilson Environmental Contracting, Inc.
