Story of a Landscape: Circular Patio Creates Backyard Destination

Source: www.TurfMagazine.com

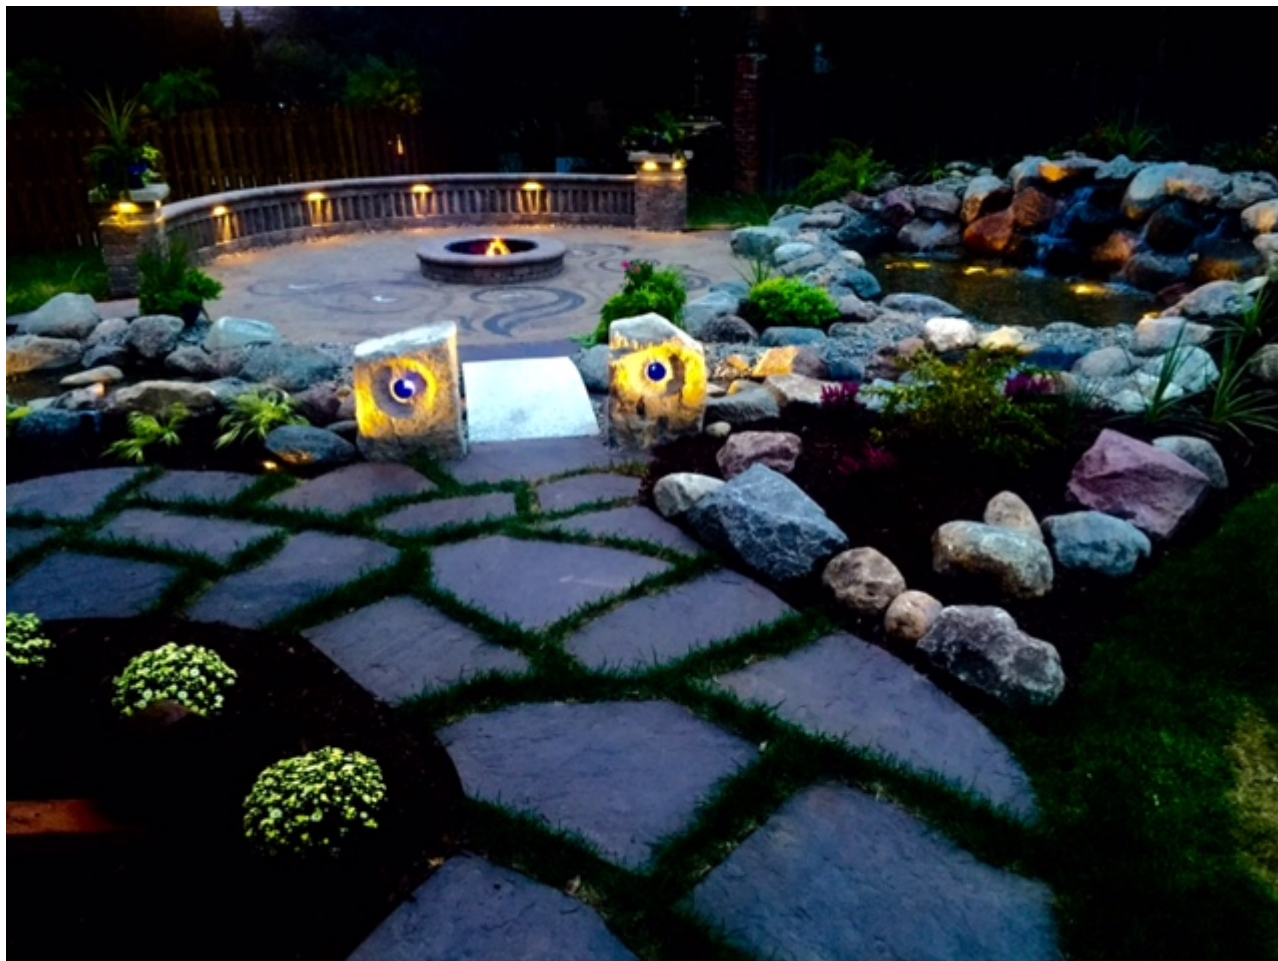
Photo: Paver Designs, LLC

Ultimately, he adds, the size of the project proved to be a help, because by digging the pool for the water feature extra deep, the lot did provide at least some of the fill needed to create enough height for a 5-foot drop to the main waterfall.

"We had to build a 6- or 7-foot mound of dirt up, then compact it properly," he says. "All of the stuff we tore out we repurposed, but I think we still ended up bringing in two dump-truck loads of dirt to get to the right height."

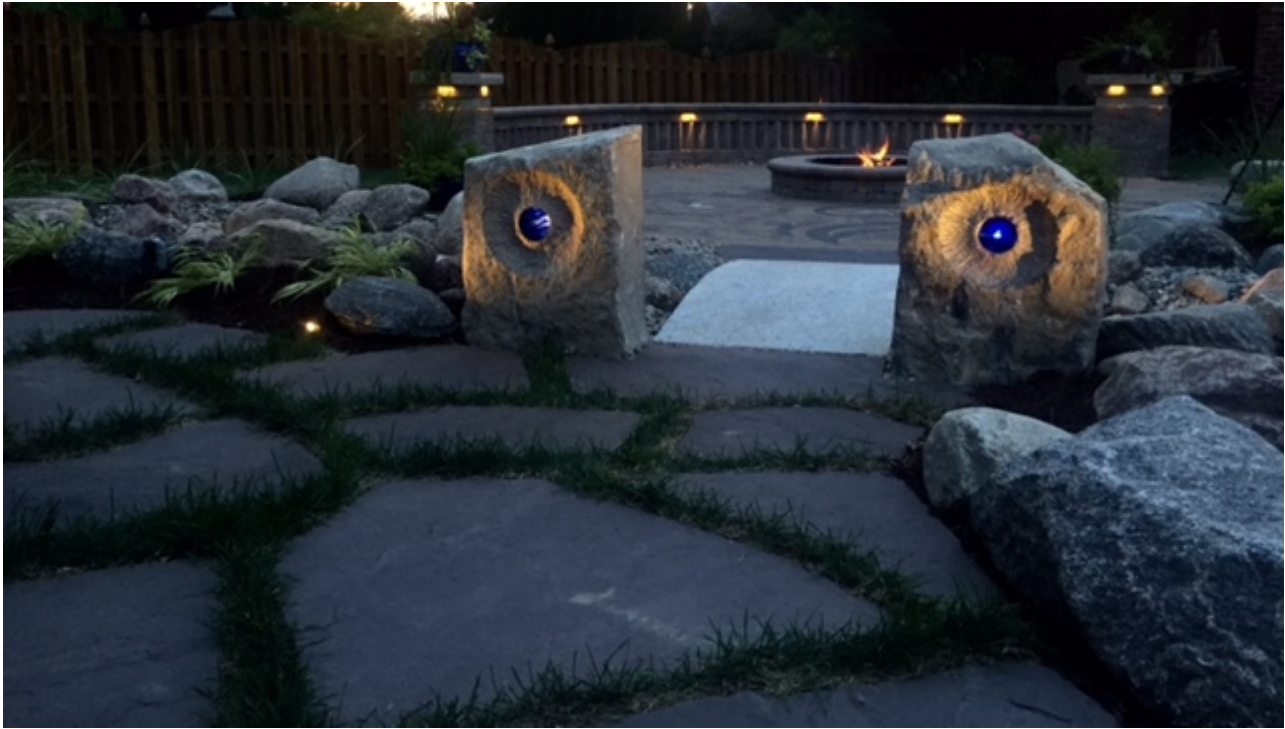
Photo: Paver Designs, LLC

The project encompasses a covered, raised patio next to the house, which Paver Design installed, the round paver patio with the fire pit and seating walls, and then the water feature.

"They wanted to look out from the raised patio and see the waterfall in the distance," says Hampton. "It breaks up the view of the fence that wraps the property, but it's also a destination spot. They were trying to make a destination in the backyard and a reason to go out there."
