## Design/Build Project Expands To Grow With Client's Needs

*What began as one residential landscape project expanded to two distinct areas when the homeowner purchased an adjacent lot. Lindgren Landscape in Fort Collins, CO took this impressive project from start to finish.*

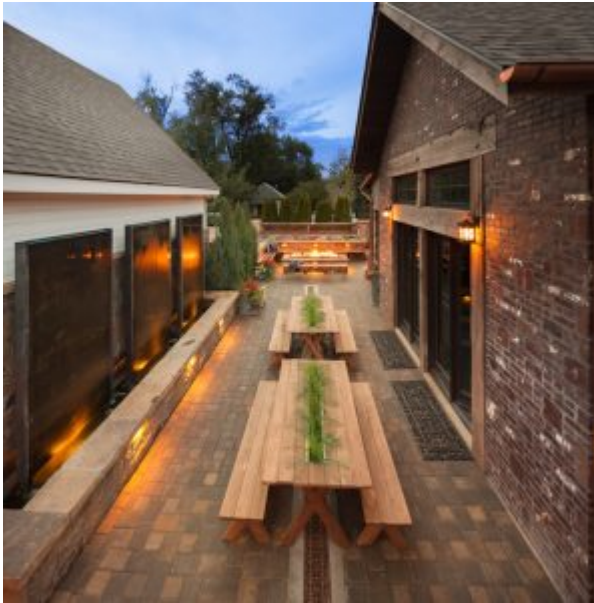
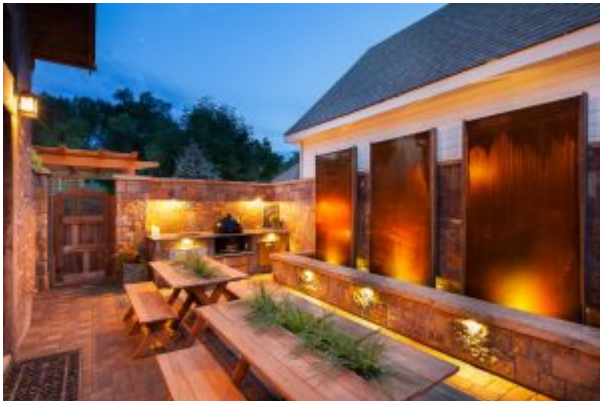
Lindgren describes the home's courtyard as having a contemporary feel. For instance, the water feature is three concrete slabs mounted in front of the neighbor's garage wall and lit from below with lighting hidden in a seat wall.

"It took a ton of design and planning," says Lindgren about his favorite feature of the project. "We had to have custom-fabricated concrete slabs, and custom steel fasteners to hold it together. The interior basin was waterproofed by a pool and spa company.

Also, custom is the rectangular concrete fire pit, which measures 7' x 3' and required a custom-made burner. The grilling area is all stainless steel and stone, with built-in cabinets.

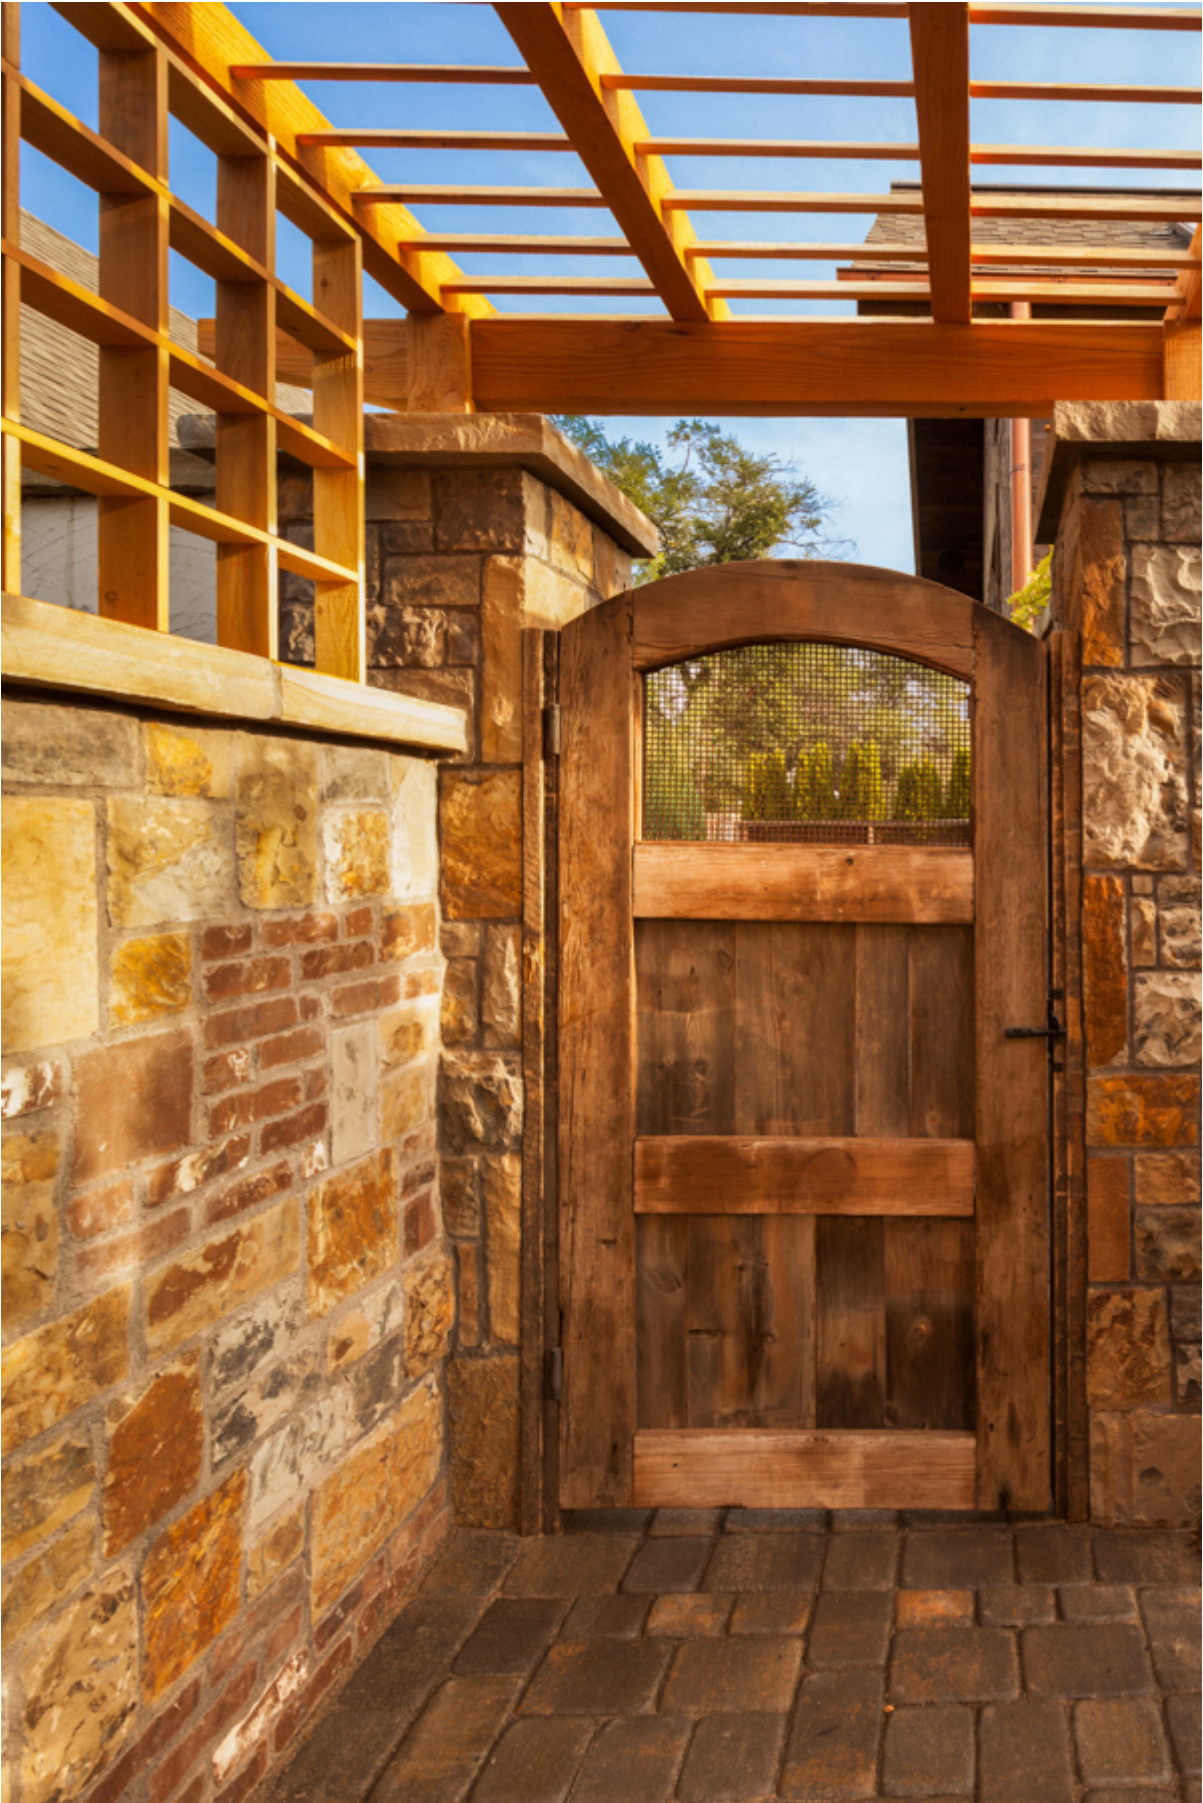
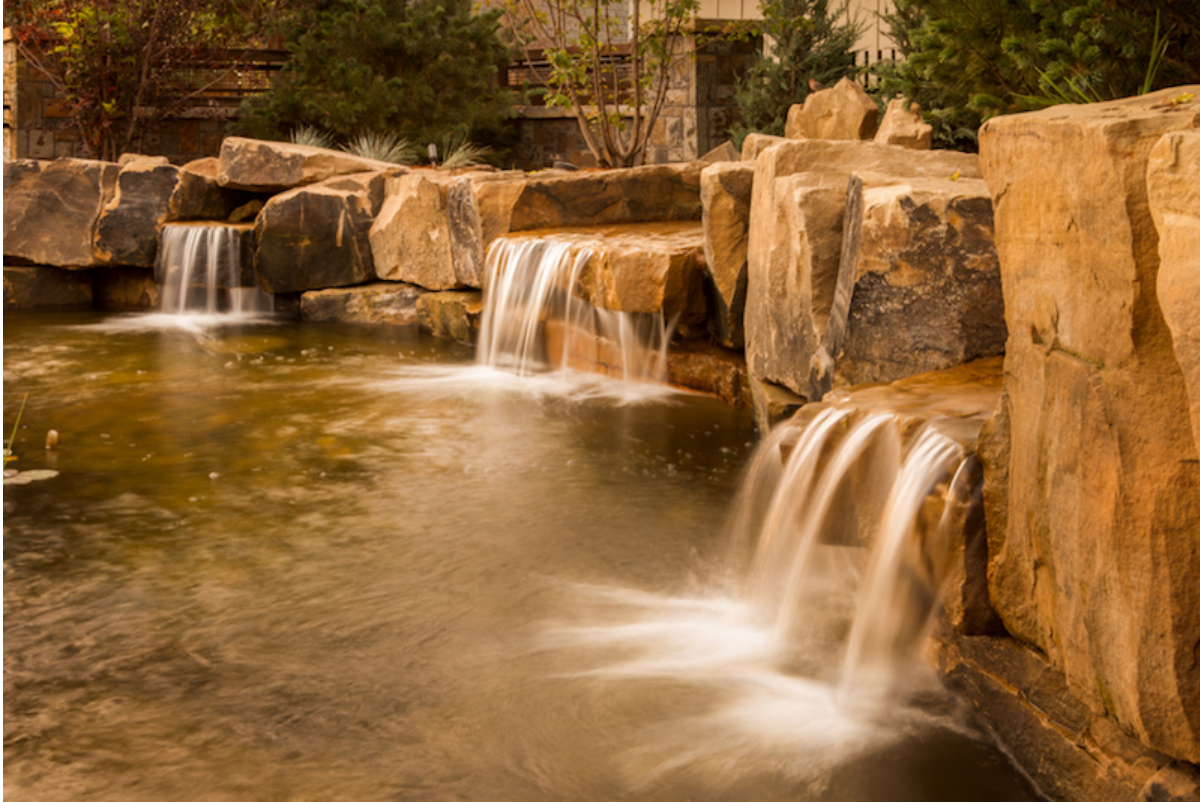
"We took the courtyard wall and put in a big rustic wooden door," he explains. "You open that and walk out and it's a whole different experience. It's a more rustic feel with boulder water features, boulders set into the patios and two pergolas. It's a whole different experience."

An excellent example of that difference is in the water feature. The large lot includes a 50' x 50' pond with boulders, three waterfalls, and a host of lily pads.

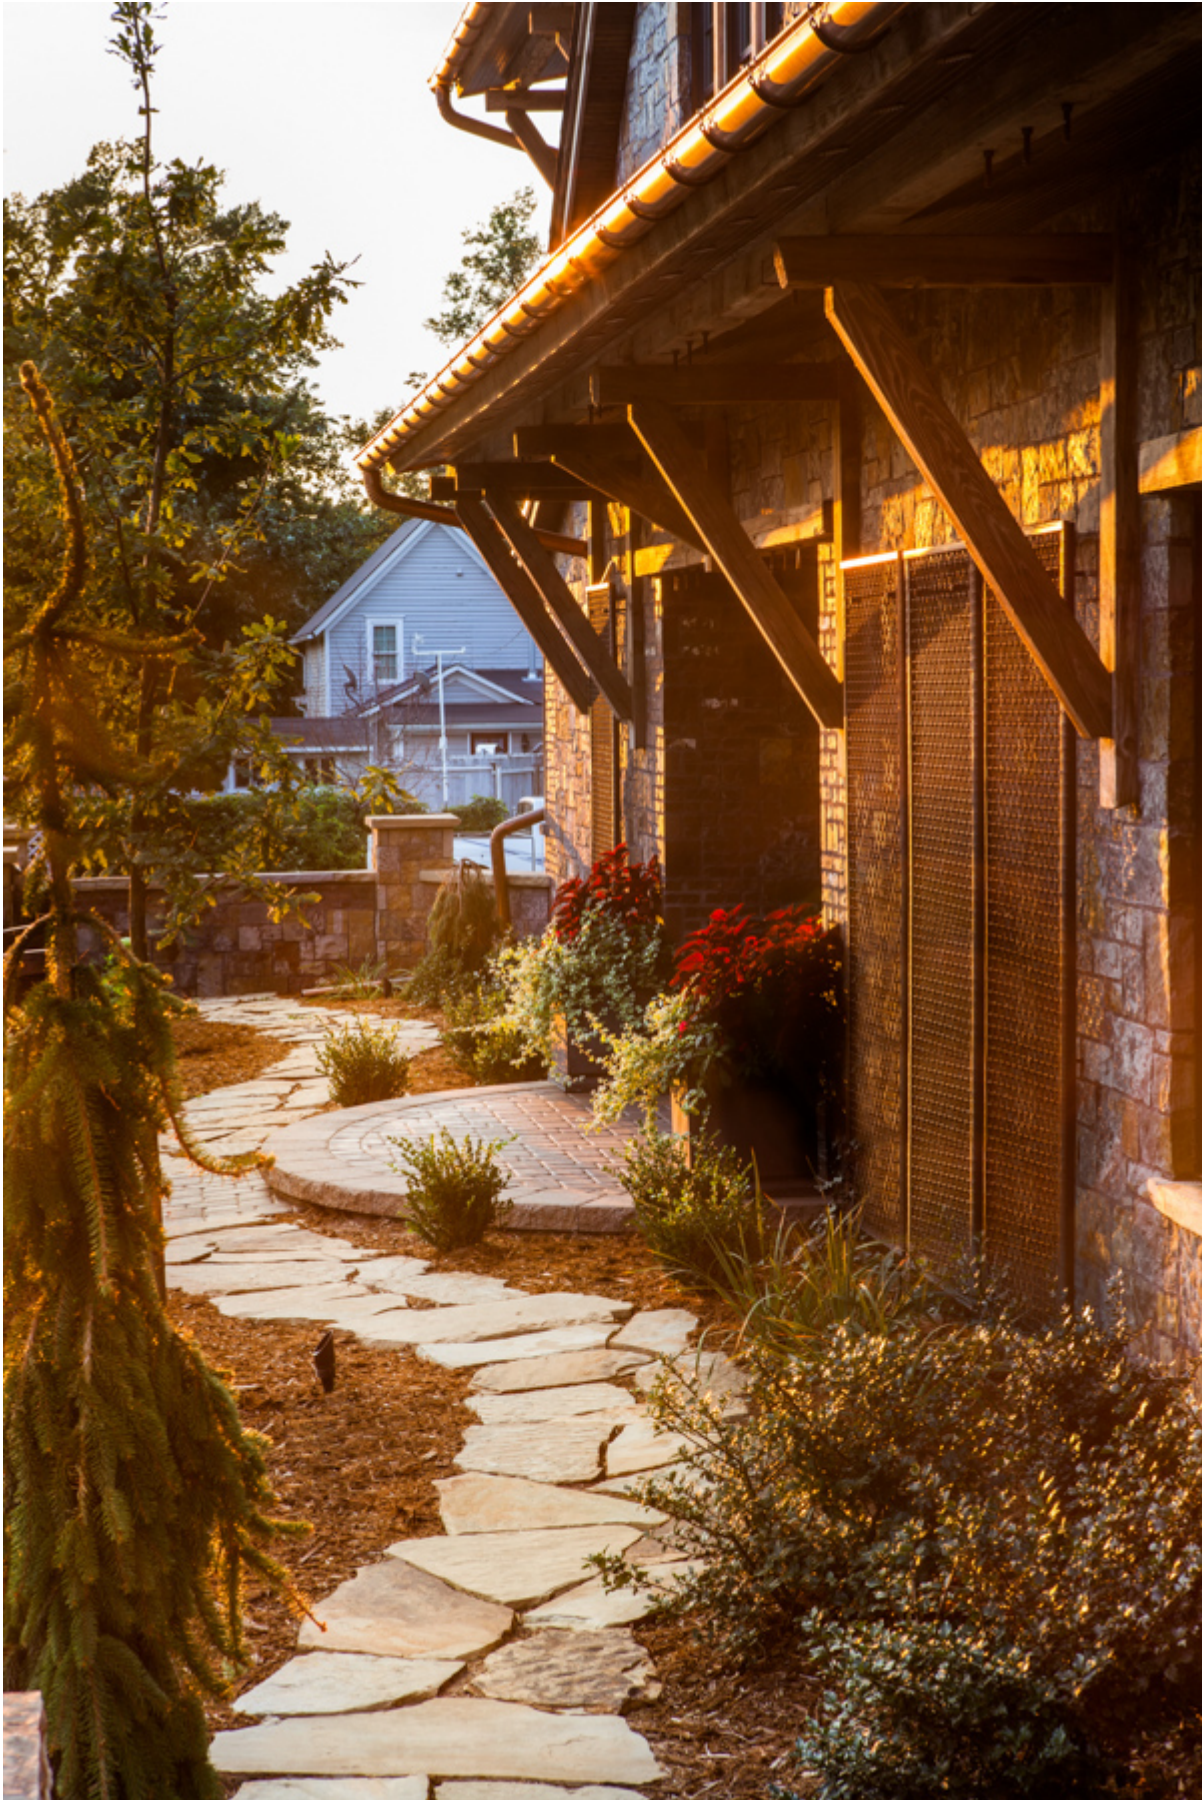
"We continued the pavers for the walking surface, but the interior courtyard is all straight lines and rectilinear design, while the backyard patio is very curvilinear," he says. "And, the seating areas include boulders. It's a much more organic feel."

The larger area includes an elevated paver patio which makes use of one of the two pergolas incorporated into the project.

"It's probably 15' x 20' and the pergola is about eight feet tall," Lindgren says. "It provides some structure above and the vertical part of the structure will allow vines to grow so it has a lattice feel on the walls for privacy."
